CONGENITAL ANOMALIES OBSERVED IN XIKRIN INDIANS IN THE AREA NEAR THE PUMA MINE IN THE STATE OF PARÁ: EVALUATION OF HEAVY METAL TERATOGENICITY

Submitted on: 03/11/2024 Publication date: 03/12/2024

Reginaldo Sabóia de Paiva¹ and Daniele Cristina Sousa da Silva²

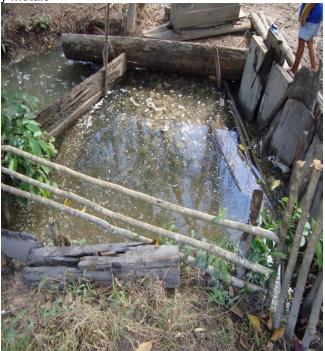
Figure 6 - Tubers such as cassava, potatoes and manioc soften in the river within 20 days. The bark of tubers, fibers or even vegetable roots has excellent ability to adsorb (ability to extract from the medium for

itself) various types of heavy metals
