**COLORS ON THE ARCHITECTURAL SURFACES OF THE CHURCH AND CASA DA MISERICORDIA/ LAR IMACULADA CONCEIÇÃO IN SÃO CRISTÓVÃO SE/BR**

**Eder Donizeti da Silva<sup>1</sup>, Adriana Dantas Nogueira<sup>2</sup>, Ana Clara Matos Araujo Lima<sup>3</sup>, Mariana Fontes de Oliveira<sup>4</sup>, Sarah Santana Iriarte<sup>5</sup>**

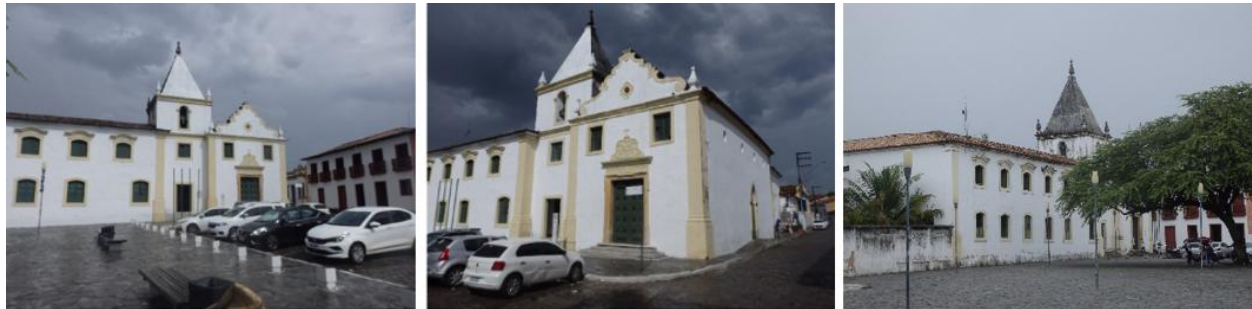
**Figure 1**

*Church and House of Mercy/Immaculate Conception Home (Church of Santa Isabel) in São Cristóvão SE/BR, in Praça de São Francisco, historic center of the city*

The Church and House of Mercy/Immaculate Conception Home, located in Praça de São Francisco in the municipality of São Cristóvão (Figure 1), is owned by the Archdiocese of Aracaju, inscribed in the Book of Fine Arts - IPHAN, V. I, page 63 of January 14, 1944 and Historical Book, V. I, page 38 of January 14, 1944, make up the landscape of St. Francis Square (listed by UNESCO in 2010 as a World Heritage Site). In Jesuit style, the church tower is one of the most important engineering achievements of the seventeenth century in the Brazilian Northeast, composing the building complex formed by the Seminary and the Church, both in Baroque style. The Church, formerly known as the Chapel and Hospital of Charity Santa Izabel, dates from construction in the first half of the seventeenth century, being one of the oldest buildings in the city of São Cristóvão (National Inventory of Real Estate and Integrated Properties – INBMI; IPHAN, 2001, p. 1).

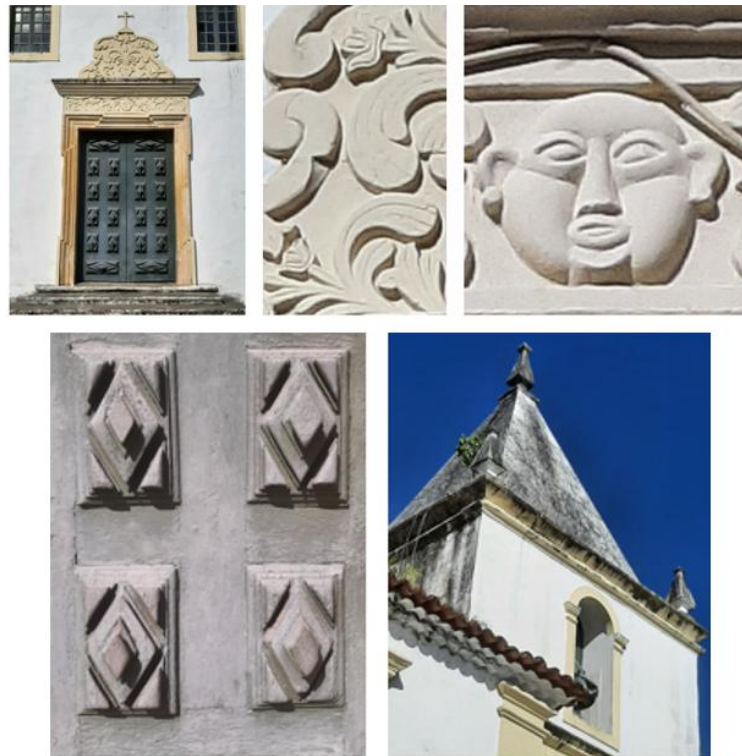
**Figure 2**

*(from left to right) – Limestone doorway; tulips and acanthus leaves on the doorway; mask; diamond-shaped cushions on the main door and tower with spires in the shape of arrows*

The main door is made of wood with diamond-shaped cushions, eight small vertical cushions and two horizontal cushions making up each leaf of the door. The tower, as is common in this typology, is low, however, it fully functions as a transitional element with the old college that became Lar da Misericórdia; Also noteworthy is the arrow shape of the dome, which, due to its monumentality, must have been difficult to build, in all the vertices of the tower and in the vertices of the pediment accompany spires, also in the form of pyramidal arrows with points in circular elements, as if to imitate the shape of the arrow of the tower's dome (Figure 2).

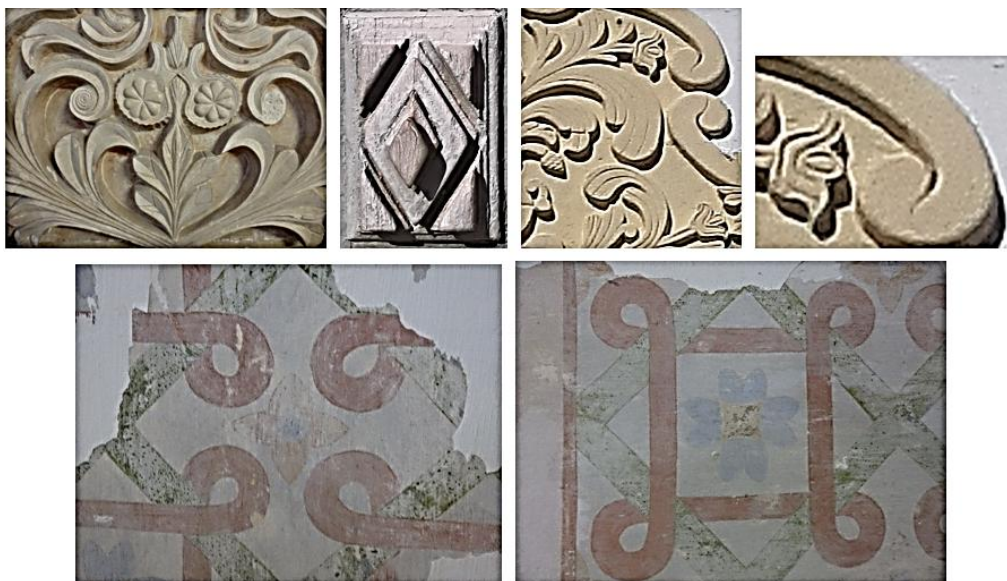
## Figure 10

(above left to right) – *Floral elements in the center of the toilet (clovers); Diamond main door; upper carving of the doorway (Tulips or lilies? Pine cones and acanthus leaves); Detail of the ornament on the side of the main doorway (Tulip? Lily? Volute).* (below) – *Paintings on the parietal surfaces of the chancel of the Church of Santa Isabel*

Seeking initial answers to the question about the date on which these paintings were made, the relationship between the design on the walls and the ornamental elements that make up the integrated assets of the church (Lorêdo, 2002) was observed, such as the stone washbasin, the cushions of the main door and the upper carving of the entrance door (Figure 10); another relevant issue is the pigments used, that is, all based on natural materials, since the colors that were observed do not have brightness (Pascual; Patinõ, 2003, p. 48), however,
