SURVEY OF PATHOLOGICAL MANIFESTATIONS OF BR-110 BY VISUAL ANALYSIS TECHNIQUE WITH MQV APPLICATION: CASE STUDY

Jardel de Moura Bezerra¹, Sâmea Valensca Alves Barros²

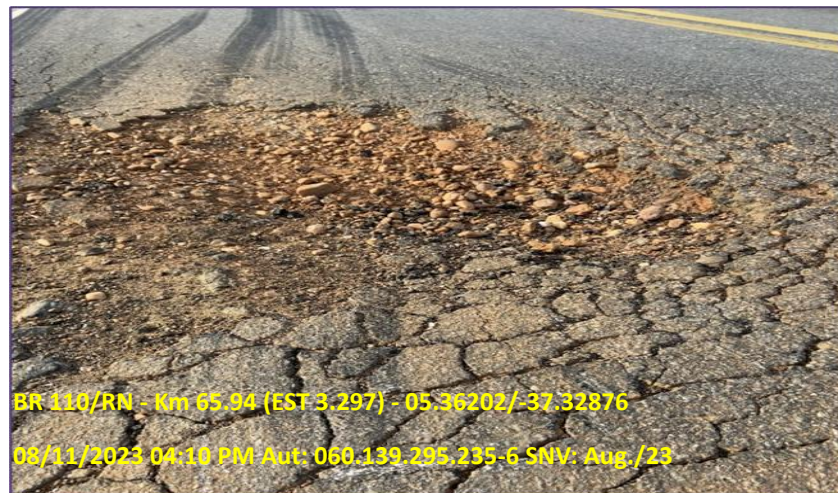
Pans or potholes were the most frequent pathologies, having different sizes and depths, always requiring the driver's attention along the way to avoid accidents. Figure 6 illustrates one of the pans found on the analyzed pavement.

Pan accompanied by "Alligator Leather" type crack

Figure 6 shows that pathologies do not always occur in isolation, because traffic, together with the action of other triggering agents, such as rainwater, initiates the disintegration of part of the coating forming the pans and, thus, promotes surface irregularities and, with the increase in traffic intensity in the first irregularities, results in a chain of effects.

According to DNIT (2006b) and Rodrigues et al. (2008), the main causes of pans are: damage to the coating caused by fatigue cracks; action of rainwater through infiltration; disaggregation of the coating on the surface of the pavement, which occurred due to traffic in points with more fragility; poor adhesion between the asphalt coating and the lower layer, and flaws in the executed project.

The analysis in Figure 6 refers to the occurrence of pathology of cavities with small depths, indicating correction with a superficial patch, which should occur cleaning the cavity after making a rectangular cut in the area that holds the pathology and removing the accumulated water, if present (RODRIGUES et al., 2008). Subsequently, the affected area must be filled with PMF (Cold Pre-Mixed), as governed by the current DNIT standard (DNER-ES 390/99), followed by compaction with a vibrating plate to ensure long-lasting adhesion with the other layers. For cases where pans or holes have reached the lower layers (base and sub-base), deep patching is recommended as a form of DNIT correction (DNER-ES 390/99).

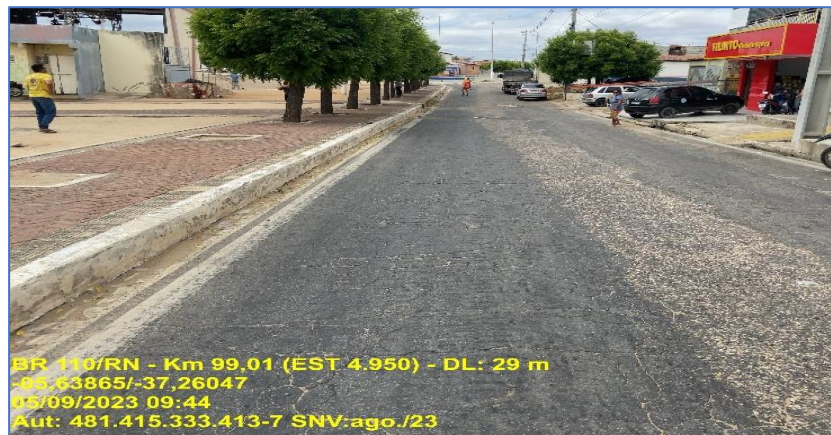
Figure 7

Along the way, some areas with wear on the pavement were noticed, and the occurrence of detachment of bituminous material in relation to the underlying layer was evident, as shown in Figure 7.

Wear

Pavement wear is a constant pathology on federal highways caused by the volatilization and oxidation of asphalt, resulting from the constant action of vehicles and weathering; construction of the pavement in bad weather conditions; localized deficiency of asphalt binder due to the clogging of the nozzles or incorrect adjustment of the spreader bar, and the presence of water inside the coating, causing the detachment of the bituminous film (DNIT, 2006b; SILVA, 2008).

There are effective measures to remedy wear on the pavement, according to Bernucci et al. (2023), the most used solution is the application of cold asphalt micro-sheath in accordance with the procedures described by the DNIT 035/2018 - ES standard. The application of this compound aims to homogeneously improve the pavement's rolling layer.

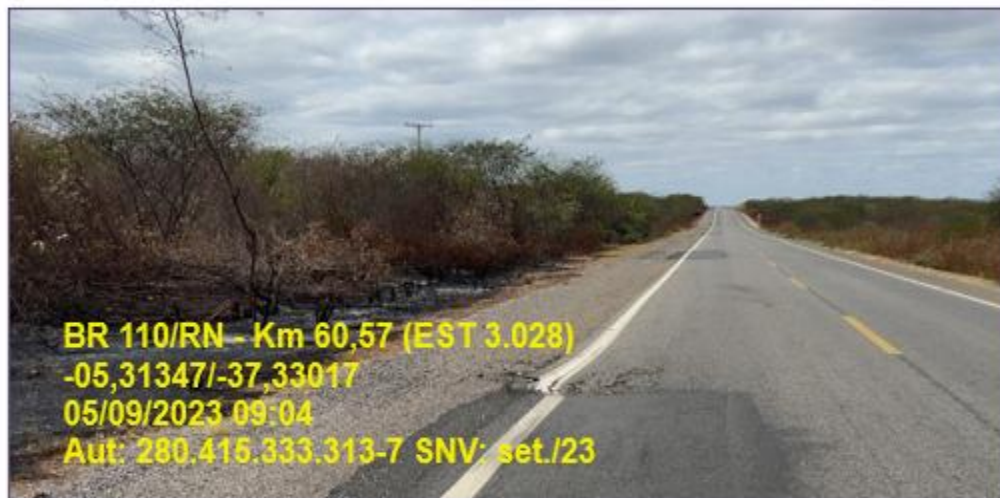
Figure 8

Some points of the studied section showed slippage of the bearing layer on the edges of the pavement (Figure 8).

Bituminous Coating Slippage

According to DNIT (2006b) and Rodrigues et al. (2008), the incidence of slips on the edge of the pavement may occur due to some factors, such as: poor dosage of the asphalt mixture; excess binder, generating high humidity from the coating to the lower layers; inadequate compaction of the asphalt mixtures or the upper portion of the base layer, and plastic deformation of the coating due to the influence of high temperatures.

Rodrigues et al. (2008) present as a corrective measure for this pathology the cutting and removal of the coating by means of cold milling, following the procedures imposed by the DNIT 159/2011 - ES standard and, subsequently, the application of asphalt mud mixture, according to DNIT 150/2010 - ES specifications.

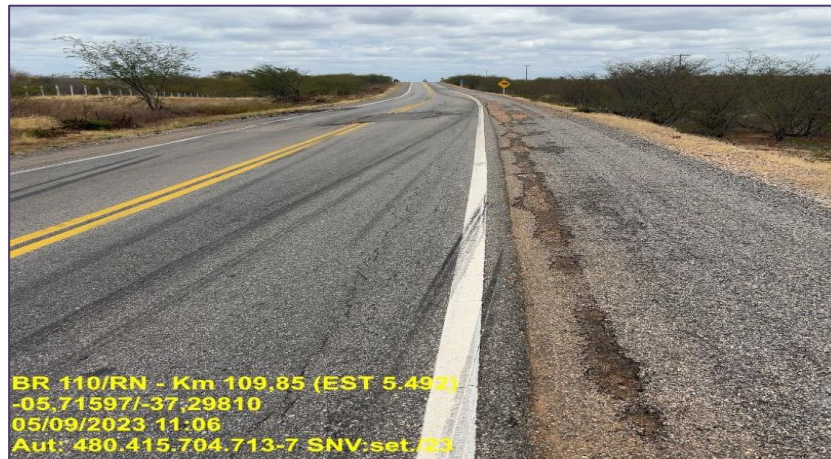
Figure 9

Long longitudinal cracks were found at some points along the pavement (Figure 9).

According to DNIT (2005) and Rodrigues et al. (2008), the appearance of these longitudinal cracks occurs due to these factors, such as: poorly executed construction joint; inadequate connection between the layers launched in sequence to form traffic lanes; emergence of settlements in the layers below the coating; contraction or expansion of the coating due to the technical gradient, or aging of the asphalt, and concentration of stresses in the vicinity where the crack manifested.

The correction of isolated cracks can be performed by sealing the cracks with asphalt emulsion and sand or stone dust in the entire affected area (DNIT, 2005). The application of the asphalt material is carried out manually, ensuring that all cracks are properly covered to prevent penetration into the lower layers, subsequently, sand or stone dust is distributed and leveled over the upper layer of the pavement using a roller (DNIT, 2005).

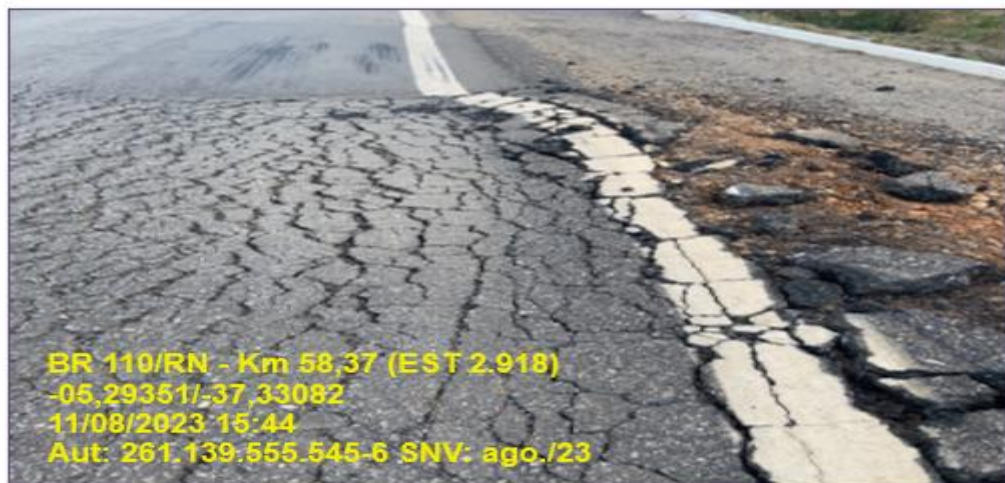
Figure 10

Another pathology existing in the analyzed pavement was the "alligator leather" type crack, identified in some isolated points during the journey (Figure 10) and in conjunction with pans (Figure 6).

According to DNIT (2005) and Rodrigues et al. (2008), the interconnected cracks that hold the appearance of alligator leather arise due to some factors, such as: contraction of the asphalt layer due to temperature variation; the material that constitutes the coating has low viscosity; constant deformations caused by traffic loads, and low thickness of the coating layer.

Rodrigues et al. (2008) suggests milling the damaged pavement in a rectangular shape, following the guidelines of the DNIT 159/2011 - ES standard and, sequentially, recommends the execution of a patch, depending on the depth that the pathology has reached. For cases where adjacent layers show deterioration, it is necessary to remove the damaged material to improve these layers.

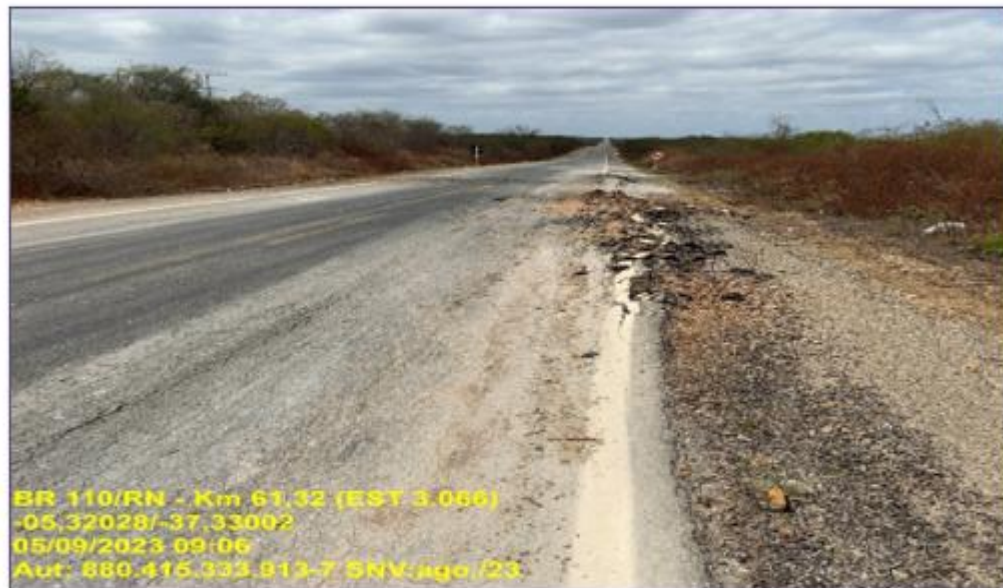
Figure 11

Some places in the studied section presented subsidence, all of them having upheaval on the edge of the pavement, characterized as plastic subsidence. The example of this type of sinking is shown in Figure 11.

Plastic sinking

Plastic sinkings are identified by depressions on the surface of the pavement, and can be generated due to some aspects, such as: plastic deformation of the upper and/or adjacent layer, which can even affect the subgrade; excessive action of traffic loads; poor soil compaction, and deficiency in the dosage of the asphalt mixture (Bernucci et al. (2008); DNIT, 2006b; SILVA, 2008).

In agreement with Farias & Corrêa (2023), the main alternative to solve this pathology would be to carry out surface milling of the pavement, correcting the sinkings greater than 20mm in the wheel tracks, then executing a new coating in CBUQ, according to the regulations of the DNIT 159/2011 - ES and DNIT 031/2006 - ES standards, respectively. The execution by milling is carried out on average with a thickness of 40mm, applying the blasting of compressed air to clean the milled area. Next, the bonding painting and filling of the milled surface in CBUQ is carried out.

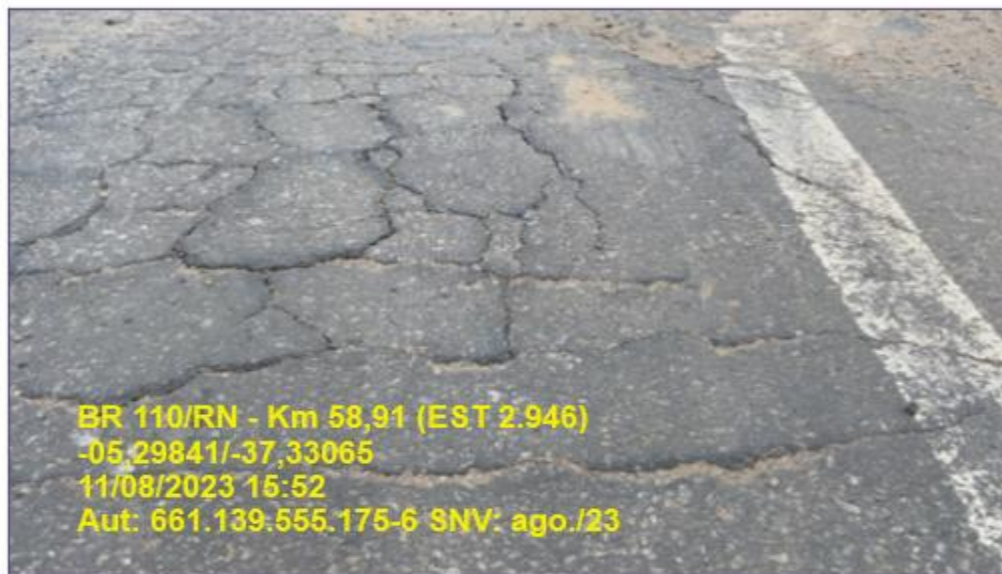
Figure 12

In some regions of the stretch, the emergence of interconnected block-like cracks was detected, as shown in Figure 12.

Interconnected block cracks

The appearance of cracks in block shapes occurs as a result, according to DNIT (2005) and Rodrigues et al. (2008), of the following aspects: contraction of the coating material, due to temperature variation; considerable loss of the characteristics of the asphalt binder; fragility in the tensile strength of the asphalt mixture; Union of transverse and longitudinal cracks in cement-based coatings.

Rodrigues et al. (2008) states that the corrections for this pathology would be the sealing of cracks with asphalt mud, following the recommendations of the DNIT 150/2010 – ES standard, and in situations where the rejuvenation of the pavement is not sufficient, milling in the affected area is indicated, followed by the execution of a deep patch.

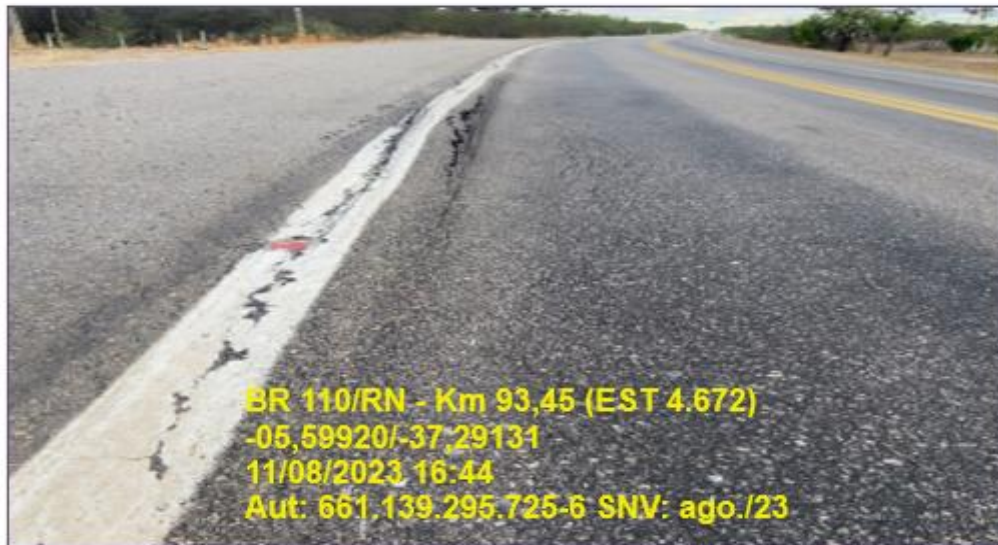
Figure 13

The presence of asphalt exudation was identified, as can be seen in Figure 13.

Exudation

According to DNIT (2005) and Silva (2008), the presence of exudation in the asphalt arises due to some factors, such as: poor dosage of the asphalt mixture, generating high content of bituminous binder and/or low void index, presenting a shiny appearance on the pavement; the temperature of the binder higher than that established at the time of mixing, causing the expansion of the asphalt and the irreversible filling of the voids between the particles, and the incidence of loads can cause an increase in the densification of the mixture in the wheel tracks, intensifying the exudation in the pavement.

The solution for this type of pathology is to combat it with pebbles, manually applying the aggregate on the exuded area, in order to reestablish the non-slip conditions of the pavement surface (DNIT, 2005). It is recommended that the service be carried out on a day with high temperatures or with previously heated aggregate.
