STANDARD METHODOLOGY FOR PUBLIC WORKS INSPECTION INTEGRATING DRONES AND ARTIFICIAL INTELLIGENCE

10.56238/edimpacto2025.063-002

Thiago Dias de Araújo¹ e Fernanda Helfer Silva²

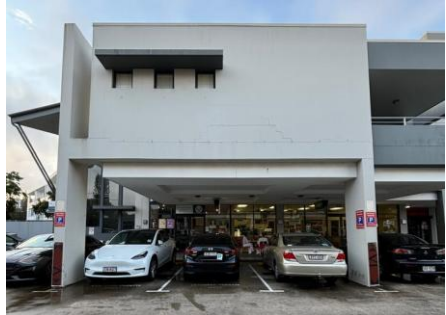
one manual flight		
Commercial Building Facade	Watts Drive, Varsity Lakes, Australia	Manual flight	Surface area= 50,52 m ²

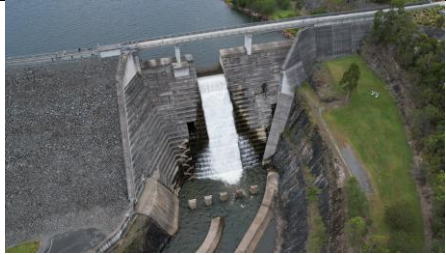
Reinforced Concrete Dam	Hinze Dam, Advancetown, Australia	A grid mapping, height = 50 m, overlap: front = 80%, side = 70%; an orbital mapping, height = 40 m; a manual flight	Maximum height of the wall= 83,1 m

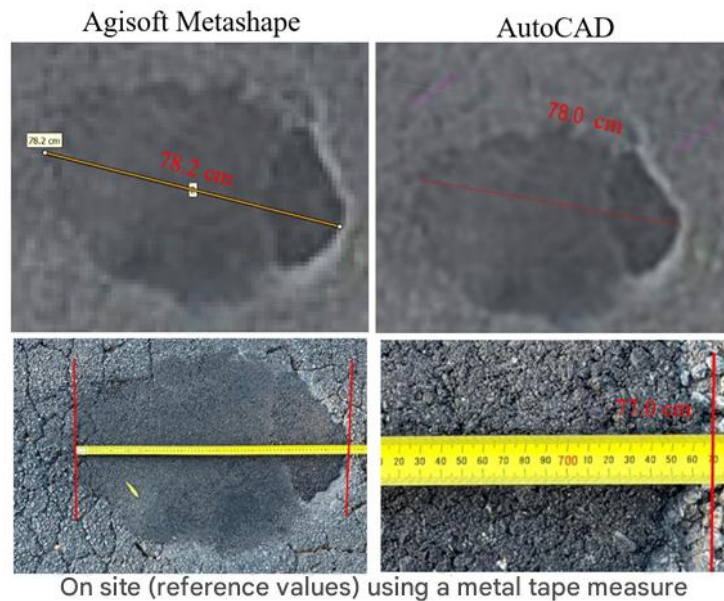
Figure 2

Comparison of measurements of hole P2 using Agisoft Metashape (top left panel), AutoCAD (top right panel), and in-situ reference values (bottom panels). The minimal discrepancies confirm the accuracy of the digital photogrammetry- and CAD-based methods

Both Agisoft Metashape and AutoCAD demonstrated high accuracy in diameter measurements, with AutoCAD presenting a slightly lower average MAPE (0.81%) compared to Agisoft (1.13%). However, discrepancies were more pronounced in area estimates, where Agisoft presented a higher MAPE (2.12%) and greater variability ($\pm 2.26\%$). AutoCAD outperformed Agisoft in both metrics, achieving greater accuracy, especially in area measurements, where it recorded an average MAPE of 1.40% ($\pm 1.63\%$). Despite these differences, all observed errors remained below 3%, indicating that the variations are statistically insignificant and do not compromise the reliability of the proposed methodology.

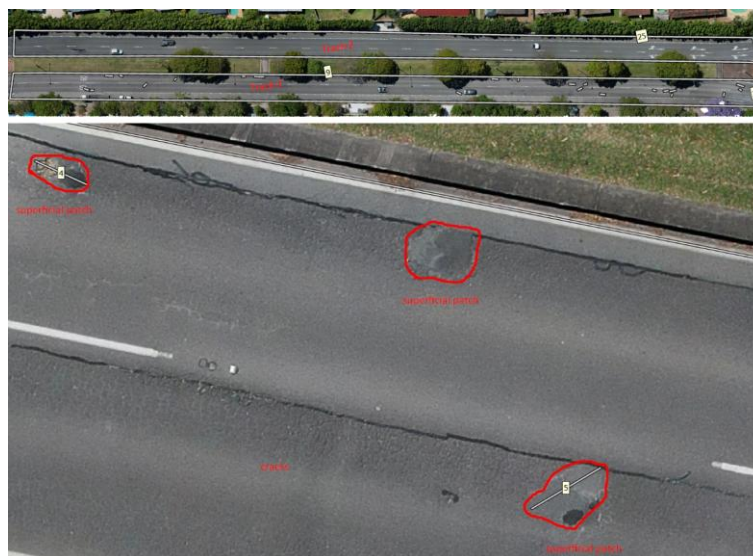
Figure 4

Orthomosaic of Christine Avenue, highlighting pathological manifestations such as cracks, surface wear, and surface patches. The image was analyzed using artificial intelligence to detect defects, identify possible causes, and suggest corrective interventions for pavement rehabilitation

Identifying and quantifying pathological manifestations is essential for defining appropriate solutions for pavement rehabilitation and public works budgeting. For the analysis, the orthomosaic of the study area (Figure 4) was inserted into the artificial intelligence assistant with the following command: "Identify the pathological manifestations, construction defects, and anomalies present in the image, indicate possible causes, and describe the recommended solutions."

Artificial intelligence analysis identified several anomalies in the pavement of Christine Avenue, Varsity Lakes, Gold Coast. Surface wear with material loss in the top layer indicates the use of inadequate or low-quality materials, exacerbated by heavy traffic. Longitudinal and transverse cracks suggest material fatigue or base/subbase failures, such as insufficient compaction.

Pavement deterioration is attributed to the use of inadequate materials [36], drainage failures [37], traffic overload [38], and lack of preventive maintenance [39]. Recommended interventions include milling damaged layers, applying polymer-modified asphalt [40], improving drainage systems [37], reinforcing compaction, and replacing subbase materials

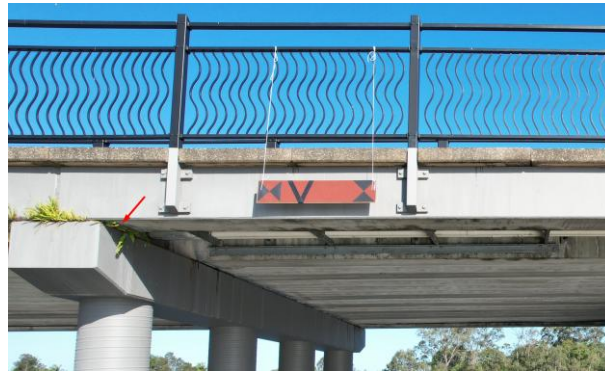
Figure 6

Vegetation growth between the beam support and the crosspiece, indicating moisture accumulation and potential drainage problems. This condition can accelerate crack expansion and corrosion, requiring specific corrective interventions. This diagnosis was correctly provided by the artificial intelligence tool developed in this study

As illustrated in Figure 6, the artificial intelligence tool correctly identified vegetation growth between the beam support and the crosspiece, indicating moisture and sediment accumulation associated with joint failures or inadequate drainage [25, 43]. This condition poses structural risks, as roots can expand cracks and accelerate corrosion. Recommended actions include removing the vegetation, sealing the cracks with epoxy or polymer-modified mortar [44], improving drainage systems [37], and applying waterproofing coatings to prevent moisture infiltration and vegetation regrowth [45]. Notably, all diagnoses, explanations, and recommendations resulted from accurate AI image analysis, and these findings were confirmed through on-site inspection.

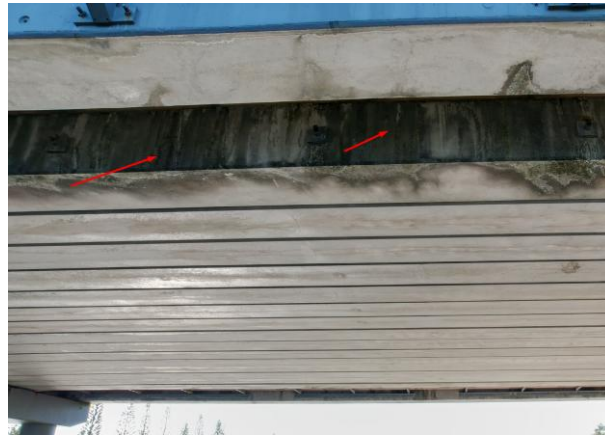
Moisture stains and signs of water runoff on the underside of the bridge under study, suggesting joint failures and deficiencies in the drainage system. These conditions contribute to reinforcement corrosion and require corrective intervention. This diagnosis was correctly provided by the artificial intelligence tool developed in this study

Figure 7 shows the identification, performed by artificial intelligence, of moisture stains and signs of water seepage on the underside of the bridge, attributed to joint failures, drainage problems, or concrete degradation. These pathologies, documented in standards such as [25] and [46], accelerate reinforcement corrosion and compromise structural durability. Measures such as joint inspection and repair [44], improved drainage systems [37], and the application of waterproofing coatings in the affected areas [45] were suggested to mitigate damage and extend the structure's service life. The entire process of diagnosis, root cause analysis, and solution definition was correctly performed by artificial intelligence and subsequently confirmed through on-site inspection.

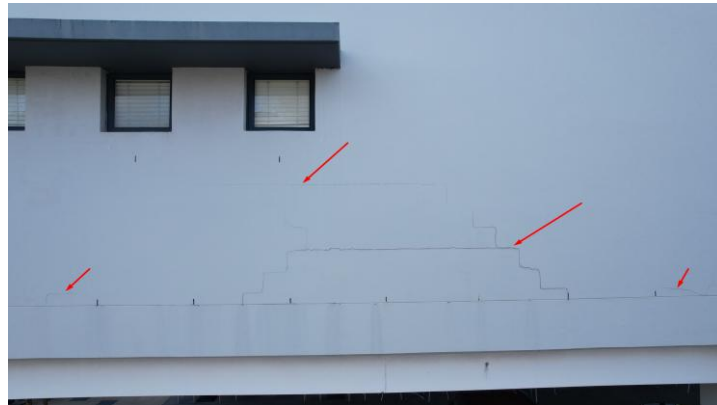
Figure 10

Identification of staircase cracks in the masonry above the long-span beam, indicating structural movements. AI analysis suggests that these cracks result from beam deflection under load, recommending the installation of expansion joints and the use of flexible materials to absorb structural stresses

In Figure 10, the AI interpreted the presence of staircase cracks in the masonry above the long-span beam, suggesting that these cracks result from the beam's natural displacements under load. This displacement generates stresses in the masonry, which lacks sufficient flexibility to accommodate such deformations. The AI recommended installing expansion joints between the beam and the masonry and using flexible materials, such as neoprene, to absorb structural movements, in addition to repairing the cracks with flexible mortar [43, 25].

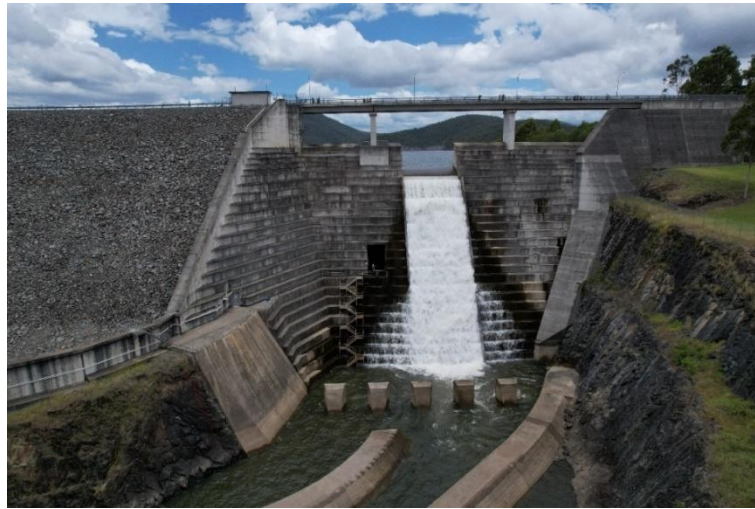
Figure 13

Overview of the Hinze Dam, Gold Coast, Queensland, Australia. AI-assisted analysis identified key pathological manifestations, including abrasive wear, expansion joint degradation, corrosion hazards, concrete cracking, and efflorescence staining

Based on Figure 13, the artificial intelligence tool accurately identified five main pathological manifestations at the Hinze Dam:

- a) Abrasive wear on the edges of the energy dissipation structure, likely caused by high-velocity water flow, as described in (ACI, 2019) [47].
- b) Degradation of expansion joints, posing a risk of loss of watertightness, in line with the concerns described in [25].
- c) Need for inspection of metal ladders and anchors due to the potential for corrosion and weakening from environmental exposure, as per guidelines in [48].
- d) Surface cracks in the concrete, characterized as microcracks in a cracking pattern, indicative of shrinkage or thermal stresses, as described in [49].
- e) Efflorescence stains, indicating leaching of cementitious materials due to water infiltration, a common problem addressed in [50].

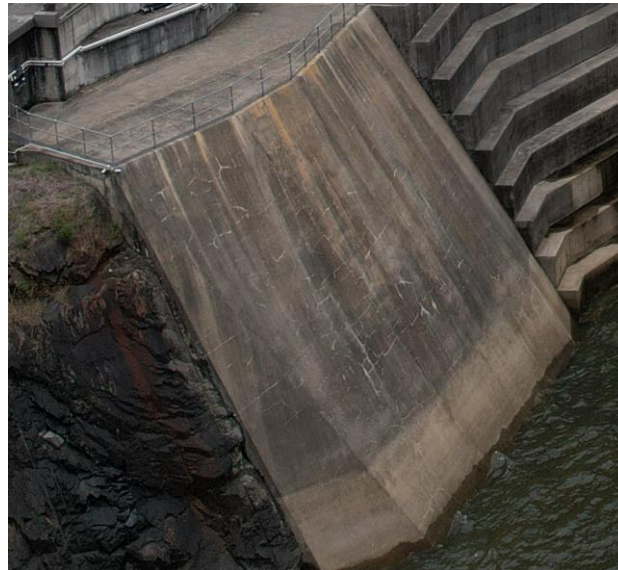
Figure 14

Detailed view of the left sidewall of the Hinze Dam, highlighting surface cracks and efflorescence stains. These conditions indicate potential structural vulnerabilities related to shrinkage, weathering, and water infiltration

During the on-site inspection, the surface cracks and efflorescence stains previously identified by artificial intelligence on the left sidewall of the Hinze Dam were confirmed (Figure 14). The cracks, associated with shrinkage and weathering, compromise the protective layer of the concrete and can increase the risk of corrosion of the reinforcement [49]. The efflorescence stains indicate water infiltration and leaching of cementitious compounds [50]. It is recommended to assess the depth of the cracks for localized repairs or the application of protective coatings, in addition to inspecting infiltration points, applying waterproofing treatments, and repairing expansion joints to maintain structural integrity.
