**PRELIMINARY ENVIRONMENTAL ASSESSMENT OF THE URBANIZATION OF THE
ESPERANÇA STREAM, NOVA ESPERANÇA DO PIRIÁ, NORTHEAST OF PARÁ**

**AVALIAÇÃO AMBIENTAL PRELIMINAR DA URBANIZAÇÃO DO CÓRREGO
ESPERANÇA, NOVA ESPERANÇA DO PIRIÁ, NORDESTE PARAENSE**

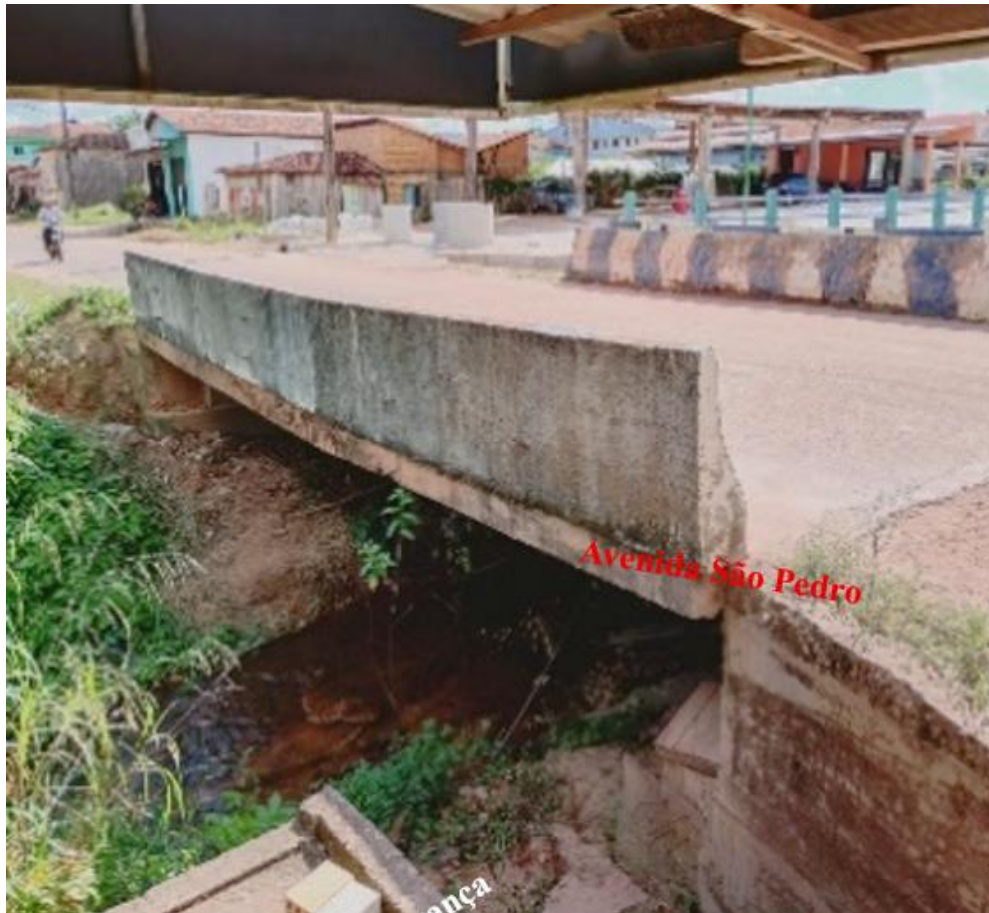
Figure 2

The method used was that of *ex post-facto* research, with *in situ observation*, associated with quantitative and qualitative coverage, to evaluate the cause-effect relationship (RAMOS *et al.*, 2025), in the urbanization of the Esperança stream (Figure 2), on Avenida São Pedro, Vila Nova neighborhood.

Hope Stream on São Pedro Avenue, Vila Nova neighborhood. New hope from Piriá, northeast of Pará. Brazil

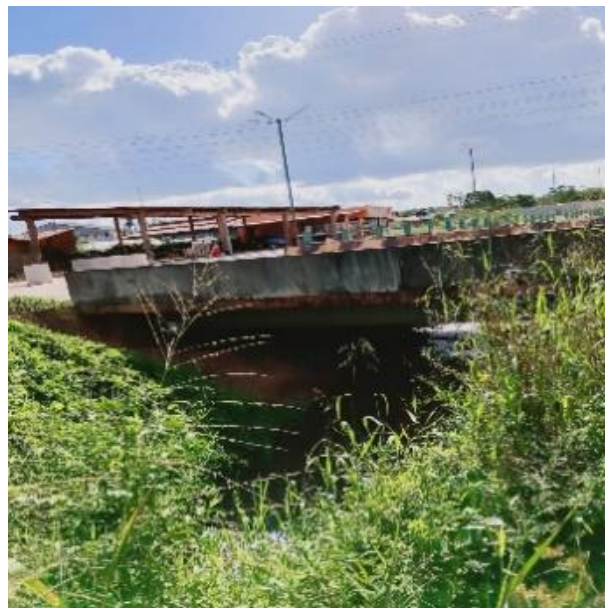
Figure 3

The banks of the stream, both to the right and to the left, upstream-downstream, are characterized by the presence of anthropogenic structures and herbaceous ruderal vegetation⁹ (Figure 5). Although *in situ* observation was not to promote the identification of the complete floristic composition. To access the thalweg, it was necessary, from the right bank, to remove the vegetation from the right bank. This fact revealed the presence of ants (Order Hymenoptera, Family, Formicidae), suggesting a maintenance of soil fertility and a potential low degree of soil contamination.

Marginal ruderal vegetation. Hope Stream. Nova Esperança do Piriá, northeast of Pará, Brazil

1. Preparation and execution of a plan for the desilting of the riverbed, with adequate management of the dredged sediments.
2. Implementation of measures to control erosive processes and recovery of degraded areas on the banks, such as revegetation with native species (riparian) and soil bioengineering techniques.
