CONGENITAL ANOMALIES OBSERVED IN XIKRIN INDIANS IN THE AREA NEAR THE PUMA MINE IN THE STATE OF PARÁ: EVALUATION OF HEAVY METAL TERATOGENICITY

ABSTRACT

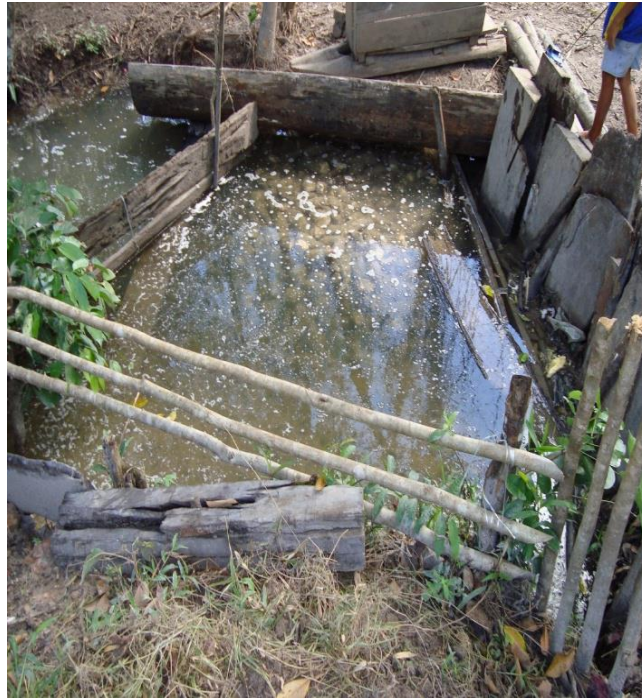
Figure 6 - Tubers such as cassava, potatoes and manioc soften in the river within 20 days. The bark of tubers, fibers or even vegetable roots has excellent ability to adsorb (ability to extract from the medium for itself) various types of heavy metals
